7. Hope All Saints: A Survey and Discussion of the Ruins and Earthworks

Maureen Bennell

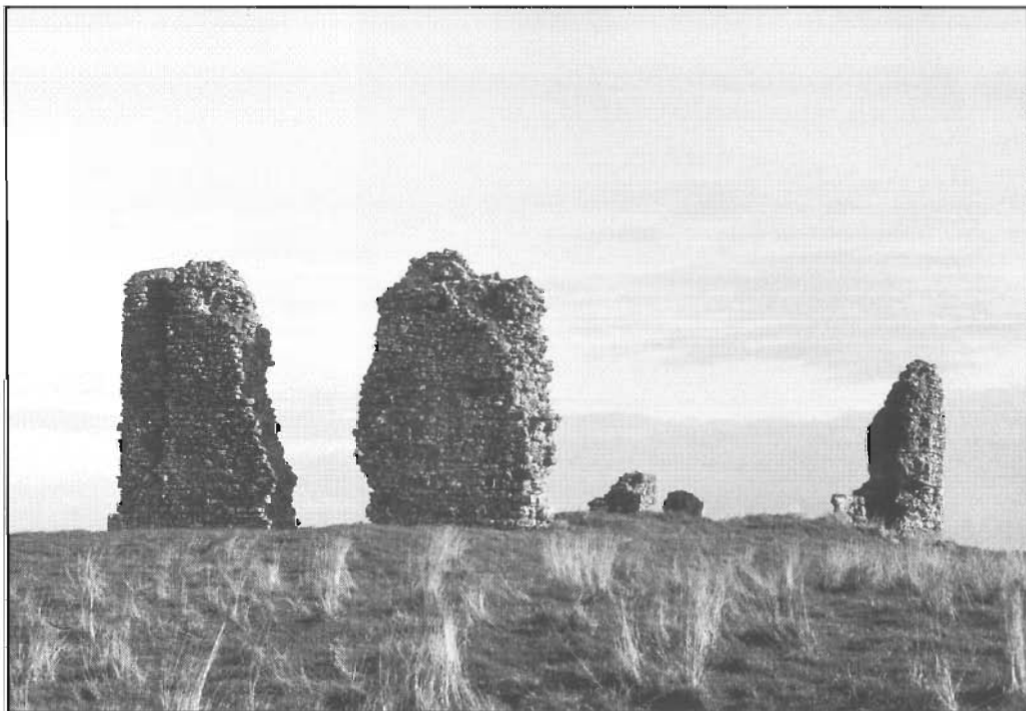
church still stood intact. Even in 1921 when Duncan sketched it, and in 1925 when Erwood recorded and photographed it, considerable amounts of the east and south walls were standing. Since then the ruins have suffered further decay as a result of natural weathering, the attentions of grazing sheep and, apparently, vandalism. The present state of the ruins is shown in Figure 7.1.

Fig. 7.1. The ruins of Hope all Saints, 1993.

Decay of the ruins continues. The large fissure running down the northern section of the west wall of the nave is diagonal and is therefore more serious than is apparent in the elevation drawings. Vegetation on the top of walls penetrates decaying mortar and causes periodic falls of stones. Stones on the ground are disturbed from time to time by human agency.

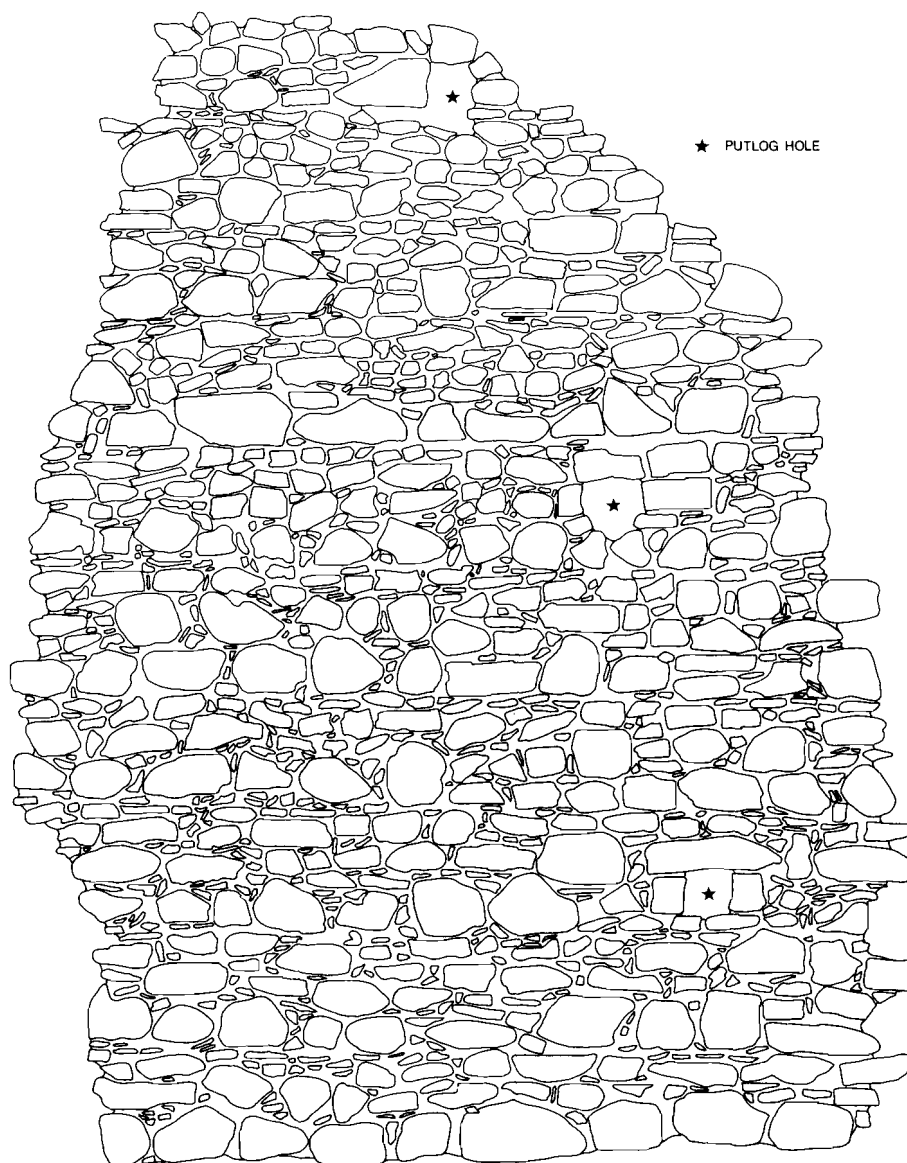
Fig. 7.2. Hope all Saints: Elevation drawing of the fabric of the exterior of the West Wall of Nave, southern end, 1988.

The present survey did not detect any visual difference in building methods between the remaining fabric of the nave and chancel. The drawings reveal a series of 'lifts' (see Fig. 7.2), each of which may represent the construction carried out in one season. In addition, during the time spent recording the stones an awareness developed that there was an underlying pattern in which the courses had been laid. In smaller details, a feeling of increasing familiarity developed as the work progressed. The same stylistic 'signature' was noted by Harris (1990) on the west front of the tower of New Romney, and he suggested that the two churches may have been built by the same team of masons.

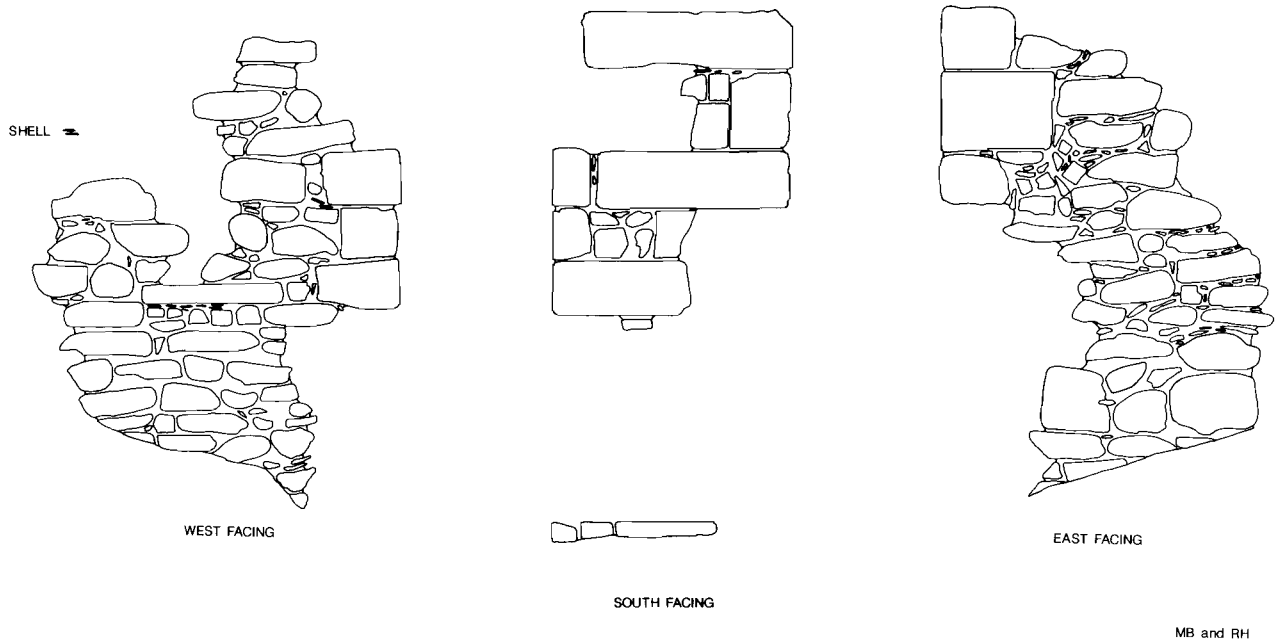
Fig. 7.3. Hope all Saints: Elevation drawing of the fabric of the Chancel Arch, North Respond, 1988.

The full history of the chancel arch cannot be deduced. The north respond contains re-used blocks of worked Caen stone and has been patched with shell in places. This patching suggests late, superficial, work. When Hasted saw the church in 1787 he was impressed by the arch with its chevron design and inserted Gothic arch. He described it as similar to the south door, so it seems reasonable to presume that the Romanesque arch existed here also. If one follows Erwood, how is one to explain a Romanesque arch with typical late Norman decoration at the entrance to a thirteenth-century chancel? And even if one discounts this arch as a detail remembered incorrectly, the heavily decorated and important south door appears too elaborate for the simple twelfth-century oratory which Erwood proposed for his first phase.

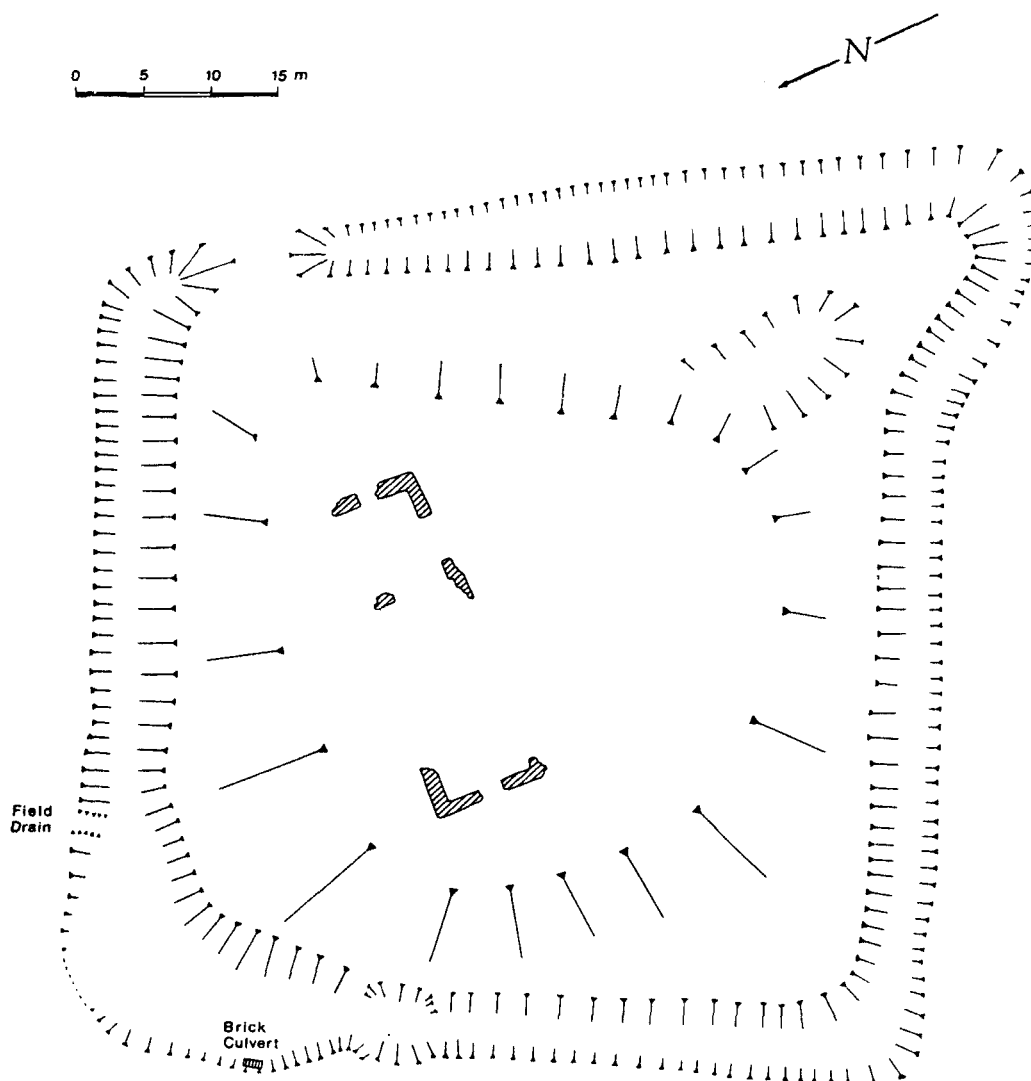
The church stands on a slight eminence and is surrounded by a ditch which is usually water-filled (Fig. 7.4). There is a slight rise in the ground here (classified by Green (1968) as a "mound", which may not be natural, see Vollans, this volume) which would be unremarked in a less low-lying part of the county. There is also the appearance of additional man-made elevation of the central area, which is more than simply the effect created by wall-tumble from the church. The ground rises steeply to the church on the north and west, and less so, beyond a narrow plateau, to the south and east. The church is aligned east-west on the highest point of the eminence: it is not set squarely within the plot enclosed by the ditch.

Fig. 7.4. Hope all Saints: Plan of the Earthworks and the Church, 1989.

The ditch encloses a roughly square plot with a causeway near the north-eastern corner, and a sunken crossing (trampled by animals) in the north-west. A field drain fills it on the north and it is emptied by another field drain through a modern culvert under a track on the west. The north-west corner widens out to form a pond. At the south-east corner there is a raised promontory or spur with an oval sunken area to its north-west.

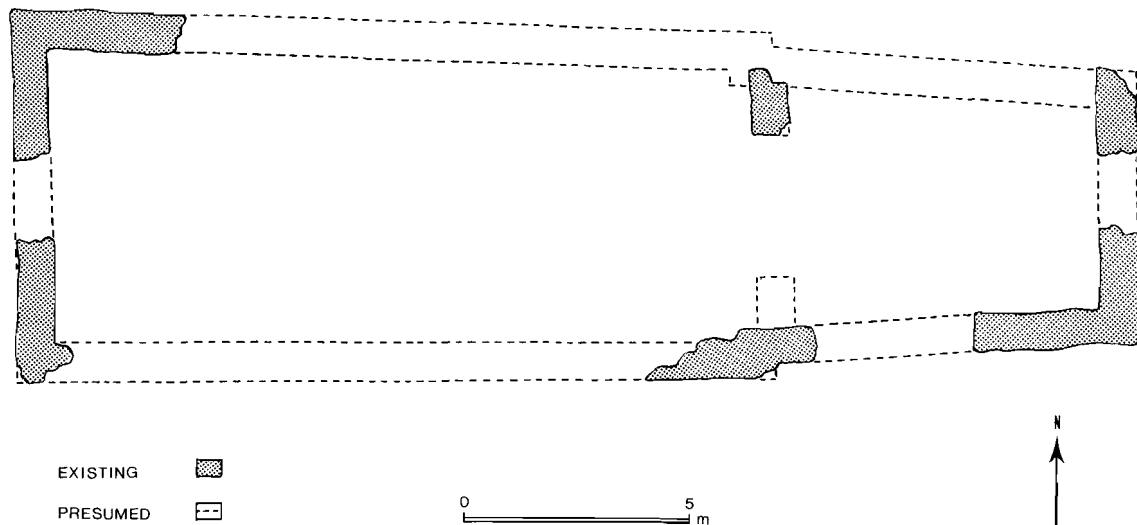
Fig. 7.5. Hope all Saints: Ground Plan of the Church, 1989.

The plan of the church (Fig. 7.5) is irregular, which is not unusual in medieval buildings. The nave tapers slightly towards the east and the chancel, instepped a little, tapers more acutely. The effect is that the responds for the chancel arch are aligned neither to the east nor the west walls. The present survey found partial bonding of the north respond and a clean edge (i.e. butt joint) to the interior of the footings of the south wall.
